Pre-Purchase Roof Report

Roof condition evidence for a home buyer before exchange.

Property	1930s semi-detached house, North West England
Instruction	Buyer requested roof evidence after Level 2 survey raised roof age, slipped coverings and chimney concerns.
Inspection type	Visual, non-invasive roof condition report from safely accessible viewpoints.
Report ref	RR-2026-0515-01

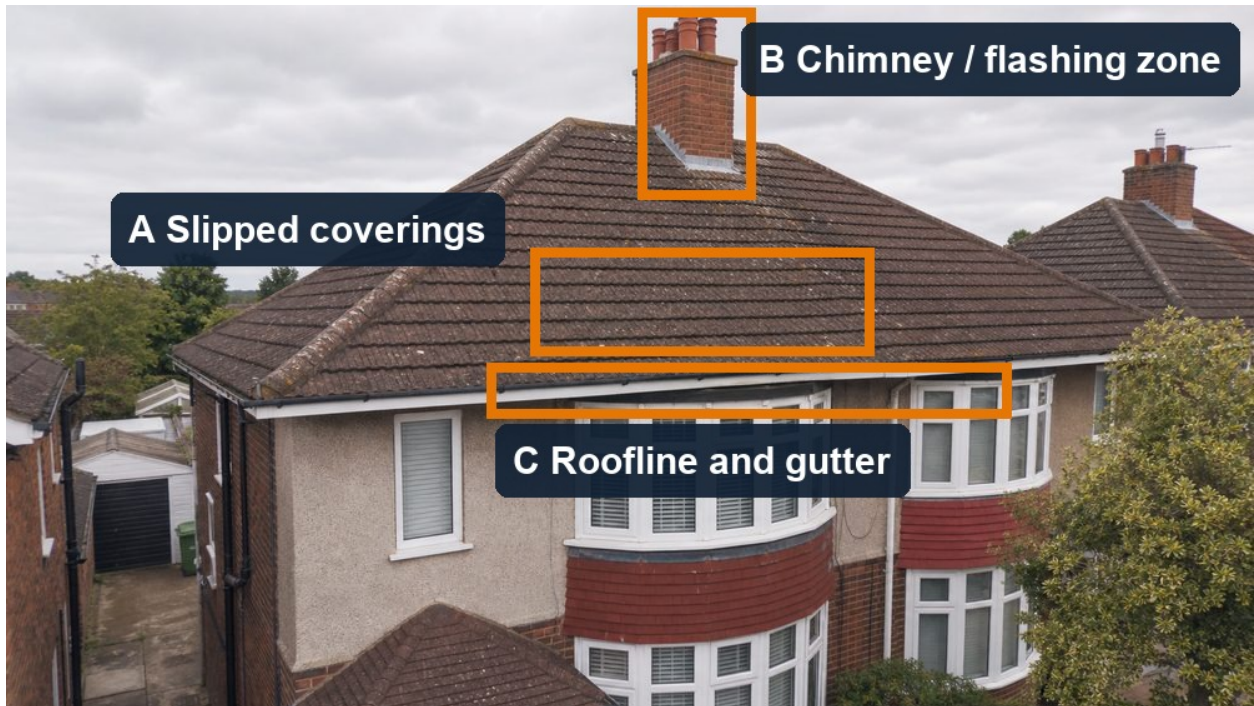
Marker	Issue Area	Buyer Relevance
A	Main roof covering	Visible slipped/displaced coverings can allow weather exposure and may indicate wider fixing fatigue.
B	Chimney/flashing zone	Defective flashings and open joints are common leak points and often affect scaffold/access cost.
C	Roofline/gutter detail	Blocked or leaking gutters can contribute to damp, staining and roofline decay.

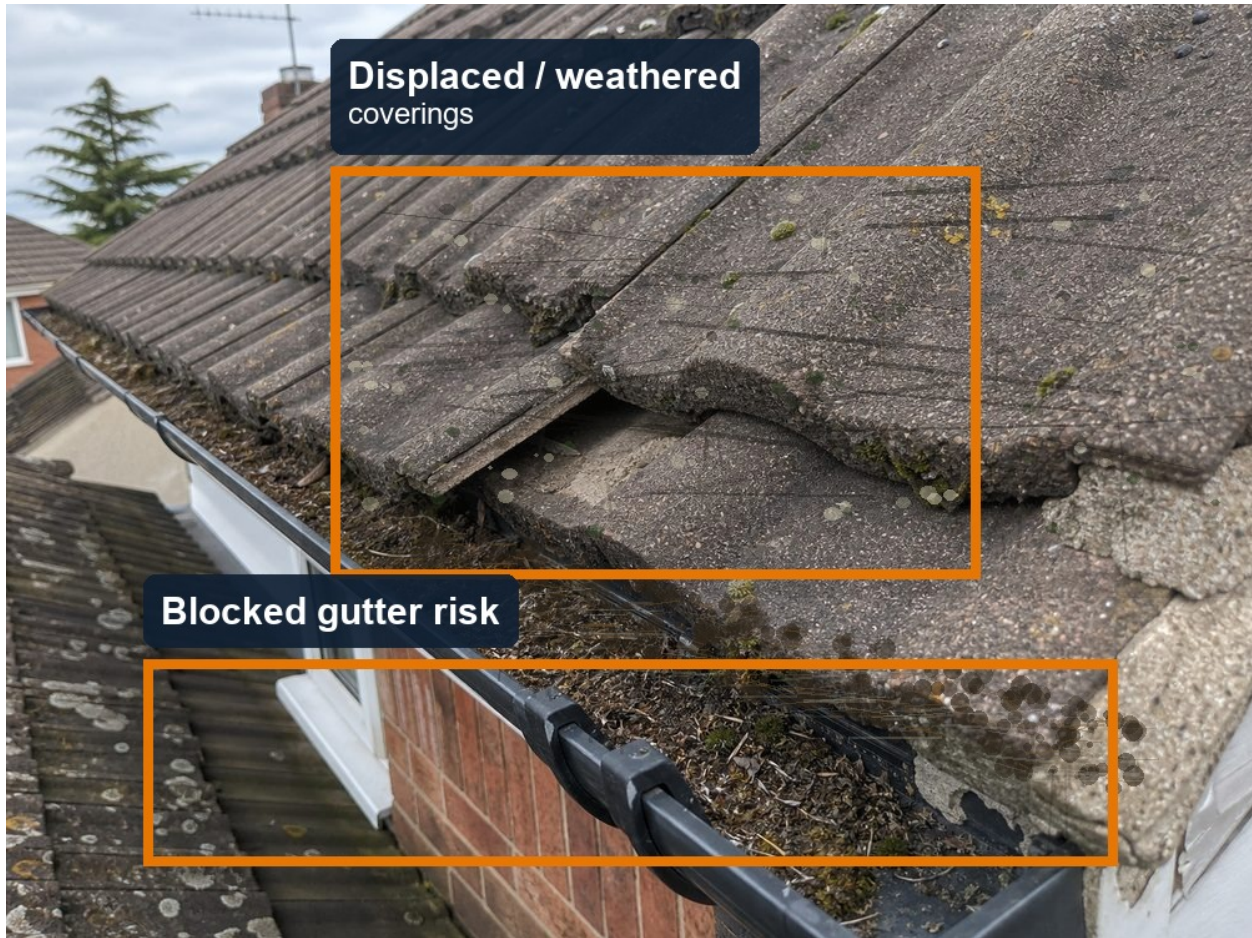
Finding 1: Slipped or Displaced Coverings

Finding ref	RR-01	Priority	High
Observation	Visible displacement/weathering is noted to the roof covering. The image suggests local areas where coverings may not be sitting correctly, with debris and gutter build-up also visible.	Guide cost	£350-£850
Buyer implication	Open or displaced coverings can allow wind-driven rain to reach the underlay and may indicate wider age-related fixing fatigue. The issue should not be ignored before exchange.	Recommended action	Ask for localised repair scope and check surrounding coverings during close access. Consider whether wider roof age makes replacement budgeting sensible.

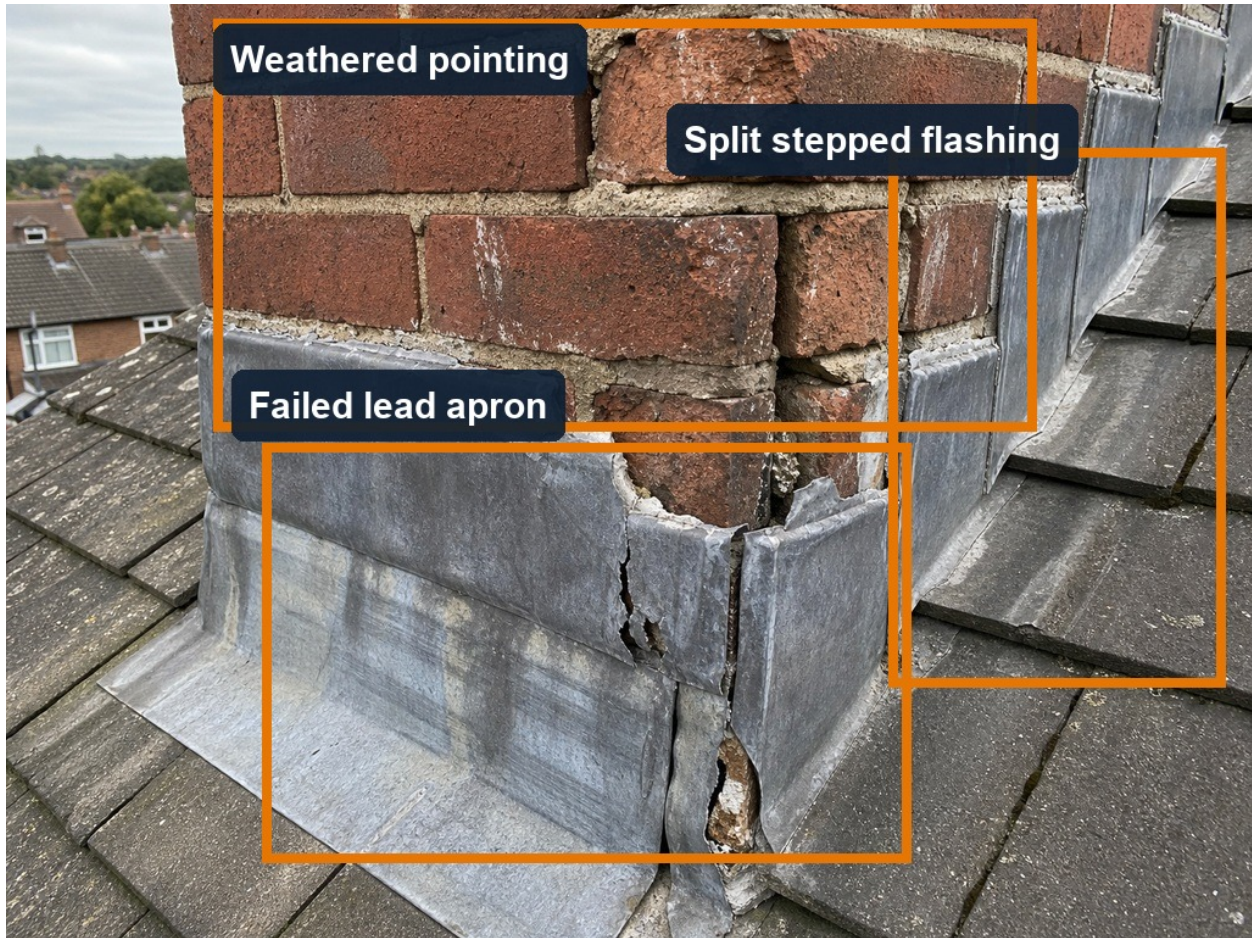
Finding 2: Chimney and Lead Flashing Zone

Finding ref	RR-02	Priority	High
Observation	The chimney/flashing zone shows weathered pointing, staining around the lead apron and stepped flashing details that should be checked closely. These are common maintenance areas on older roofs, even where parts of the leadwork appear previously repaired.	Guide cost	£750-£1,650
Buyer implication	Chimney and flashing defects can allow water entry around an exposed roof junction. The visible condition may be serviceable short term, but a buyer should budget for repair review because scaffold or tower access can materially affect final cost.	Recommended action	Request close inspection of the pointing, lead apron, soakers/stepped flashing and flashing. Ask whether repointing, lead dressing or local flashing repairs are needed before completion or can be budgeted after purchase.

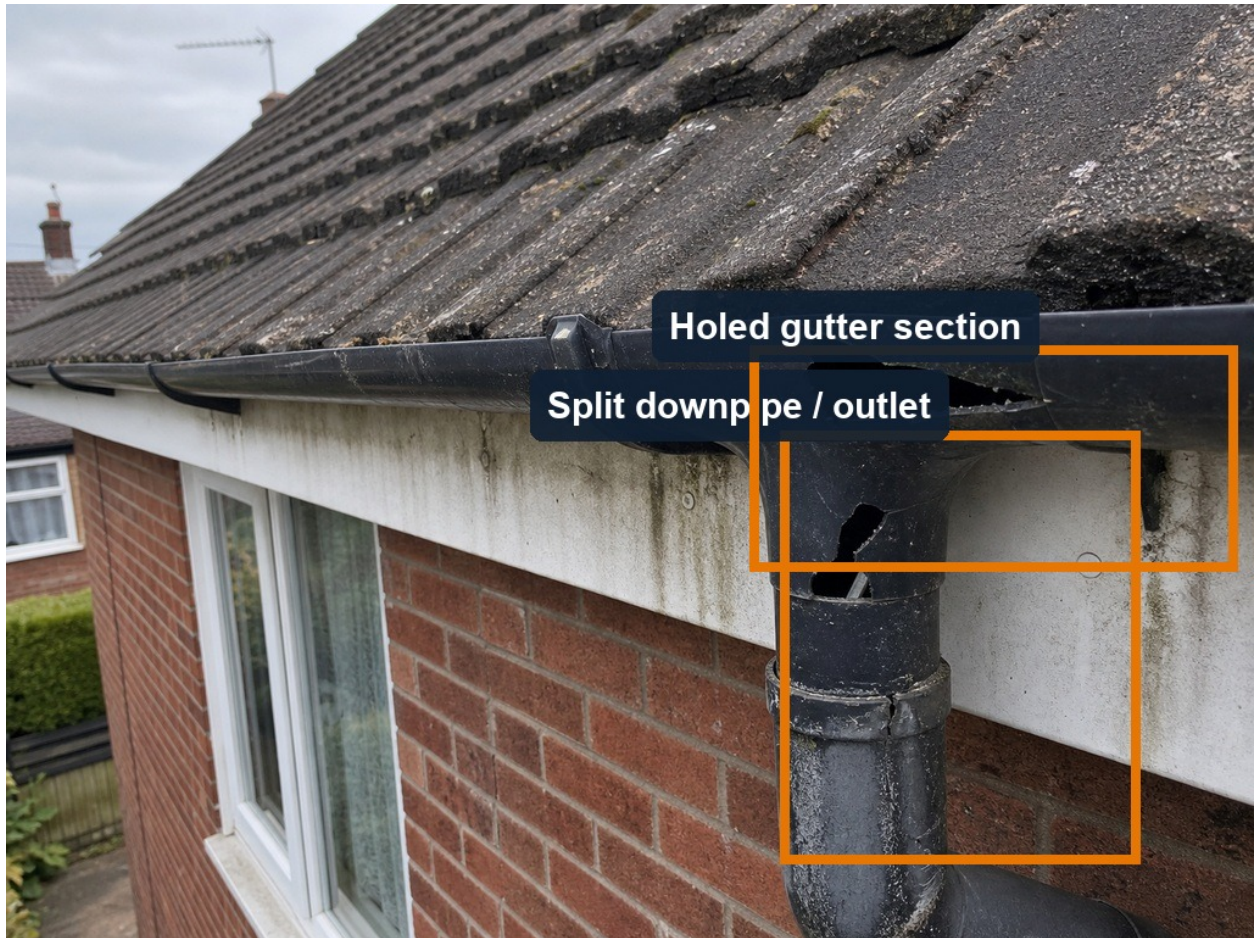
Finding 3: Roofline, Gutter and Access Limitations

Finding ref	RR-03	Priority	High
Observation	A holed gutter section and split outlet/downpipe detail are visible at the roofline. Staining to the fascia below indicates repeated overflow or leakage in this area.	Guide cost	£280-£750
Buyer implication	Failed guttering can discharge water onto the fascia, wall face and lower roof edge. Continued overflow may contribute to staining, damp risk and timber/fascia deterioration if not repaired.	Recommended action	Replace the failed outlet/downpipe section rather than relying on temporary sealant. Check gutter falls, brackets and adjacent fascia condition during the same visit.
